Hazard Elimination Project Evaluation

Project Log # 200502100

Hazard Elimination Project W-4021

**Evaluation of the Pavement Widening to Provide Two Foot Paved Shoulders,
Pavement Resurfacing, and Guardrail Installations on NC 68 from
SR 2011 (Edgefield Road) to the Rockingham County Line
Guilford County**

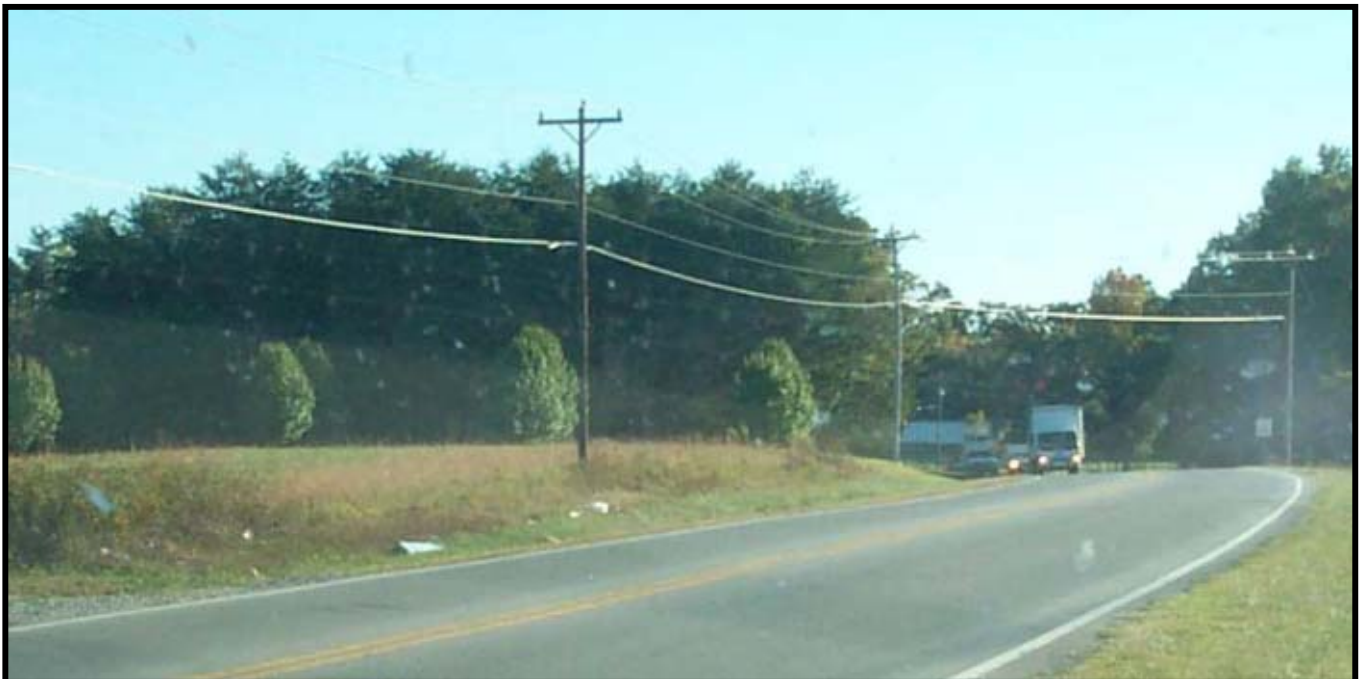
Although the project did decrease the crash severity of ROR crashes, it did not prevent motorists from leaving the roadway. The construction of paved shoulders did not correct the Run-Off-Road crash problem as intended. In the before period, there were thirty-four (34) ROR Crashes. In the after period, there were thirty-eight (38) ROR Crashes. The same crash pattern persists although improvements were made to the roadway from the before to the after period. Note that in the after period, 47.0 percent of ROR Crashes occurred at night, which may suggest the possibility of poor visibility. During the field investigation, the pavement width was measured in a cross section typical of the entire treatment location. The lane widths were measured at 13' and the paved shoulder at 1' in each direction. It appears that NC 68 is not currently striped with a 12' travel lane and 2' paved shoulder, as was intended in the project description.

Driving Southbound on NC 68. At this location, the lane width was measured at 13' and the paved shoulder width was measured at 1' in both directions.
